THE HEALTH PHYSICS ASPECTS OF THE FAILURE OF A PLUTONIUM-BERYLLIUM START-UP SOURCE IN THE SAFARI 1 REACTOR

D. K. CRAIG, B. C. WINKLER and J. R. COLLEY

National Nuclear Research Centre, Pelindaba, South Africa

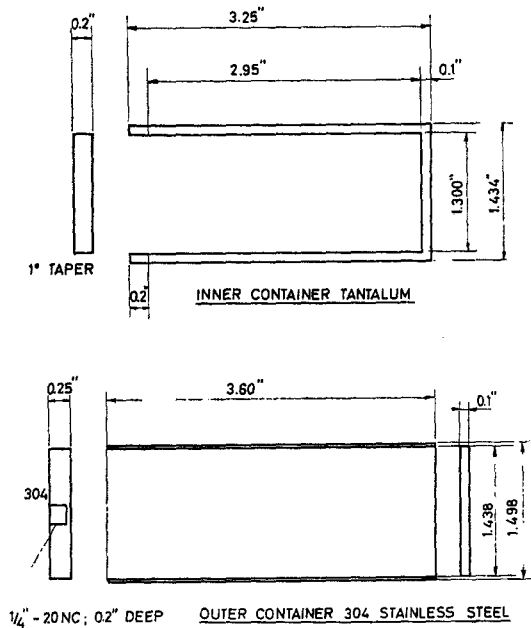
On March 15, 1965, a 10 Ci Pu-Be start-up source (Fig. 1) was placed in the bottom of an aluminium basket 1.875 in. i.d. and inserted into a 2.00 in. i.d. hollow beryllium reflector element in the reactor core. Fuel element loading commenced next day and the reactor went critical with nine fuel elements and four control rods during the evening of March 18. Following control rod calibration, the source was moved to core location F7 (Fig. 2) on March 23, and on the following day, after loading more elements, the full operating core, as shown in Fig. 2, was attained. On March 25 the source was moved to reactor location E1 to increase the counting rate in the start-up channel, and low power runs were made up to

FIG. 1. Container of plutonium-beryllium source.

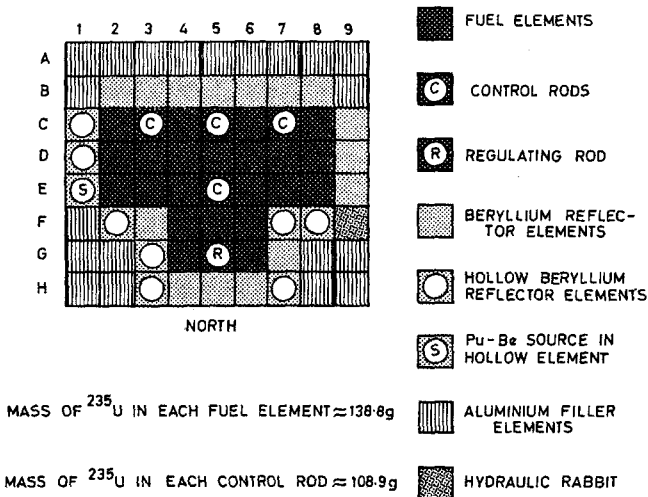
FIG. 2. Safari 1 core configuration at time of incident.

personnel in the area wore full-face or half-face respirators. A 5 ml water sample from core location E2 (Fig. 2) gave over 90,000 counts/min compared with 6000–10,000 counts/min for similar samples from adjacent channels. This differential was confirmed during a short run at 50 kW and the reactor was shut down just before midnight in the belief that the high readings may have been due to a faulty fuel element. At 01:16 hr on the next morning (April 24) a new fuel element was fitted. On

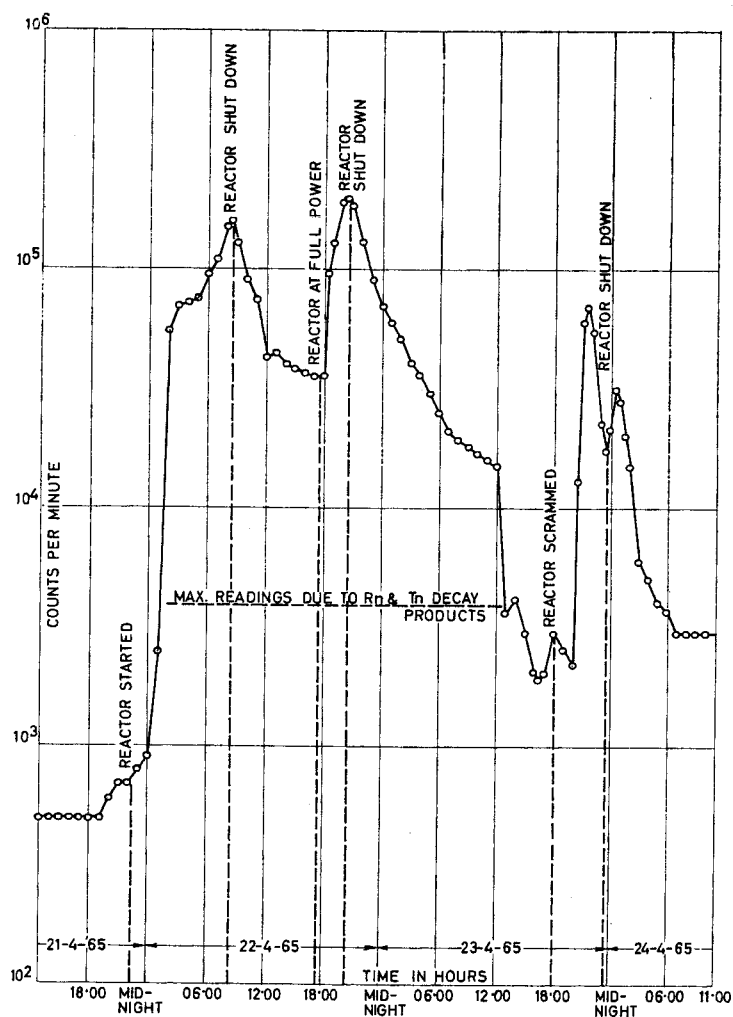
During the rise to power the stack particulate monitor readings rose steadily (Fig. 3) and by 02:00 hr the shift health physicist had to change the range from 10^4 to 10^6 counts/min. Neither the rate of increase of this reading nor that of the

FIG. 3. Stack particulate monitor readings from 14:00 hr 21.4.65 to 09:00 hr on 24.4.65.

Figures 3 and 4 show that airborne radioactivity was released from the stack whenever the reactor was operated. The analysis of gas samples showed that the gaseous activity was almost entirely due to ^{133}Xe and ^{135}Xe , which

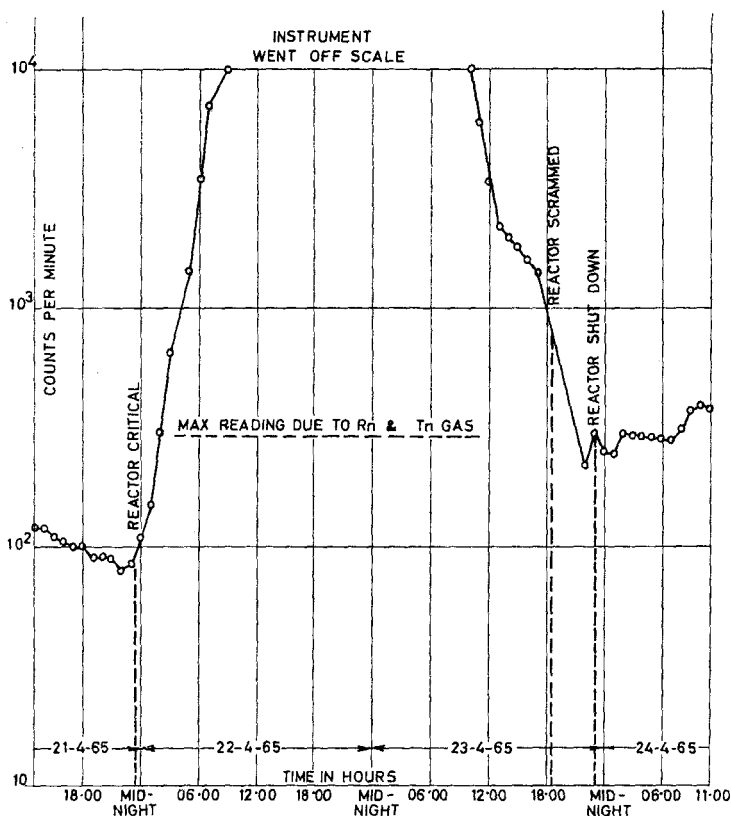
stack gaseous monitor reading (Fig. 4) was recognized as a serious abnormal condition. At 03:30 hr the duct monitor tripped the reactor hall ventilation system again and, although previous peaks in the duct monitor has been observed (Fig. 5), these were attributed to instrument behaviour. Routine smear tests and air samples taken at this time throughout the reactor area showed no increases above normal background. However, at 04:19 hr the secondary water monitor showed abnormally high readings, not due to contamination from the

FIG. 4. Stack gaseous monitor readings from 14:00 hr on 21.4.65 to 09:00 hr on 24.4.65.

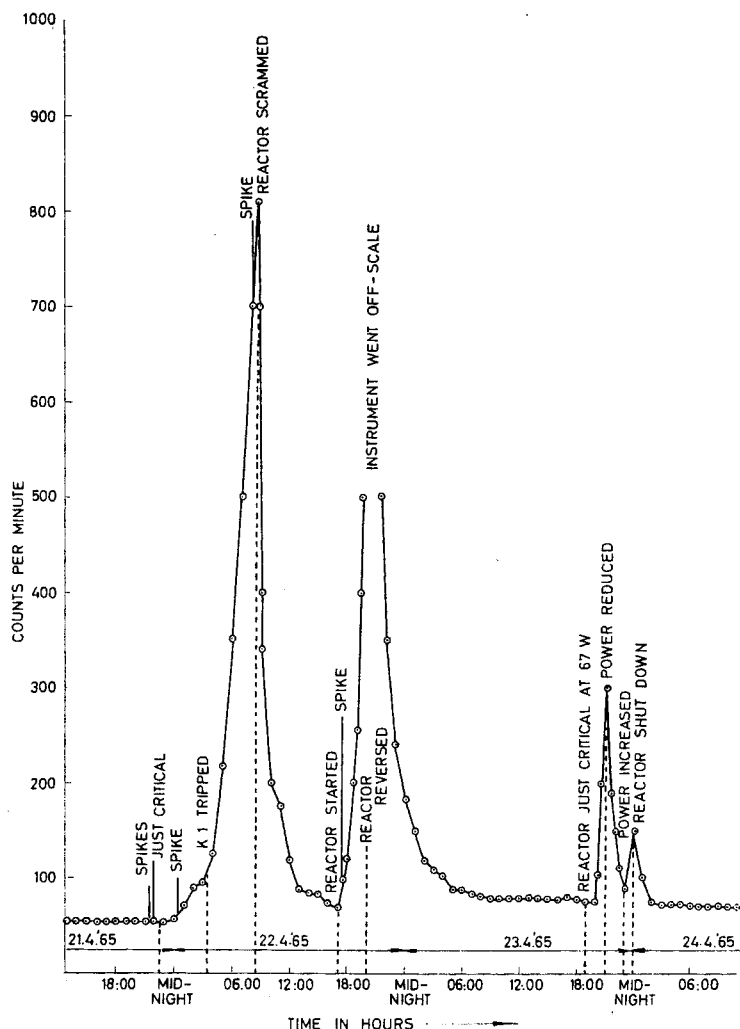
Fig. 5. Reactor hall ventilation duct (K1) monitor readings from 14:00 hr on 21.4.65 to 09:00 hr on 24.4.65.

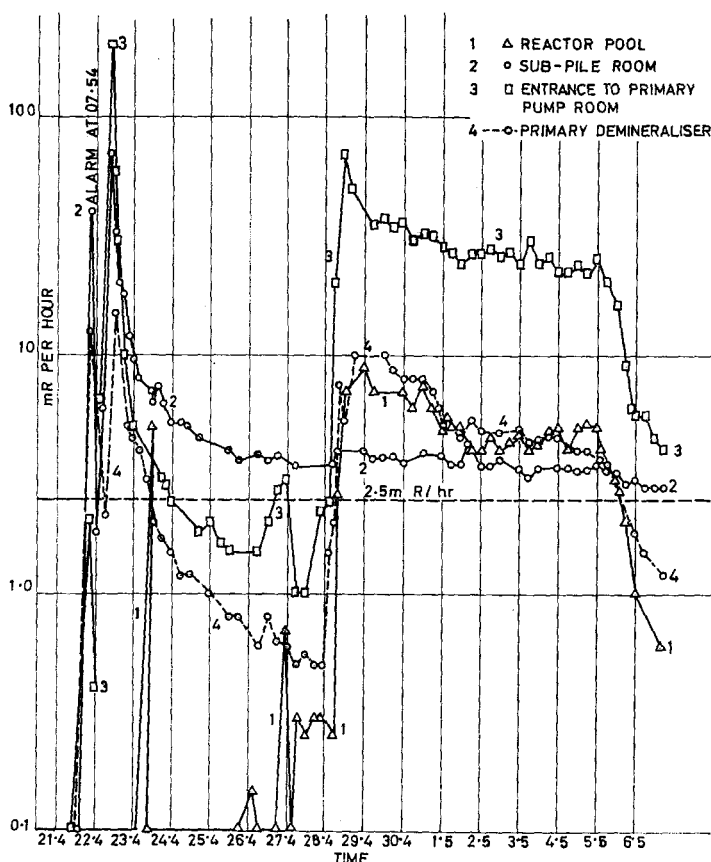
FIG. 6. Some area radiation monitor readings for the period April 21 through May 6, 1965.

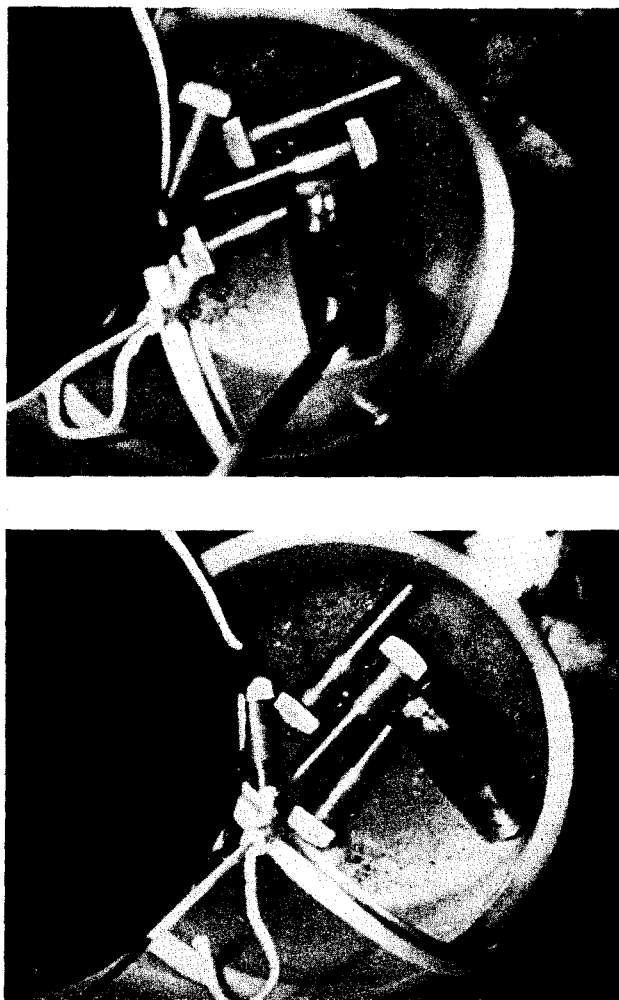
samples from location E2 still showed very high readings and it was decided to remove the basket containing the source and nine beryllium plugs for visual examination. The source was removed with considerable difficulty late on April 26, and was seen to have split longitudinally (Fig. 7). Discoloration of the steel case indicated that very high temperatures had been reached. On the following morning activity and irradiation levels were seen to be decreasing, and the alpha activity in the pool water was about $5 \times 10^{-6} \mu\text{Ci/ml}$. Two days were spent in cleaning up the reactor area and consideration was given to the safety of starting up the reactor again. Although some chips of the Pu-Be source were probably in the reactor vessel, primary coolant circuit and pool, and would release further fission products on start up, it

FIG. 7. Photographs of ruptured source container. These photographs were taken with the source in a plastic bucket, located under about 12 ft of water. The upper photograph shows the longitudinal rupture along the top of the container. The lower photograph was taken with the container rotated through 90°.

Calculations that were carried out subsequent to the rupture indicate that the cooling for the source, in the core location chosen, was probably inadequate for operation at 6.7 MW.

was decided that these could best be disposed of by operating the plant and allowing the primary circuit and pool filters to remove the plutonium and fission products. With a close watch on activity and radiation levels the reactor was run up to 2.2 MW without a source in the afternoon of April 28 and kept steady for two hours during observations. At 18:00 hr power was increased to 4.4 MW, and the main source of stack activity was shown to be the degasifier. By 19:12 hrs the reactor was at full power and all monitor readings began to level off. Full power was maintained during a warranty run which lasted for the next 7 days. After this the reactor was shut down with the reactor and pool water purification systems still running continuously to clean up as much activity as possible.
