CONTAMINATION OF RESIDENTIAL AREAS
BY A FORMER RADIUM PROCESSING PLANT

George F. Gandy & Arnold W. Fleischmann
Radiation Health Services
Department of Health, N.S.W., Australia

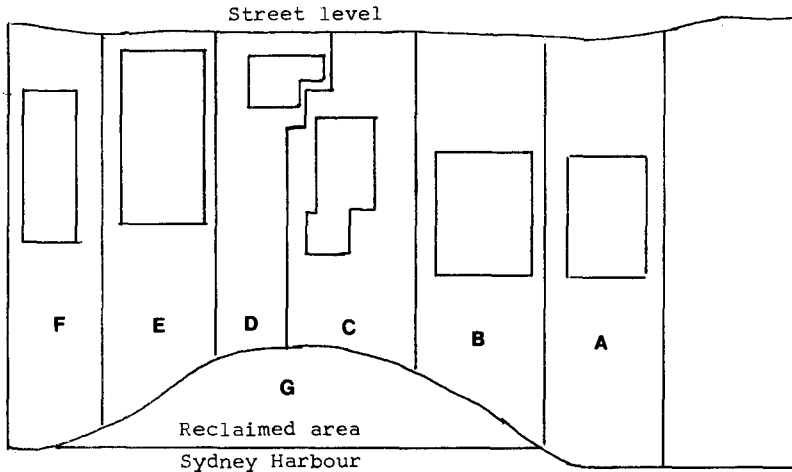
Fig. 1

The processing plant was built on land reclaimed from Sydney harbour and extended up a sheer cliff face to road level. A series of terraces were constructed to enable level surfaces to be created for the construction of the plant. The total area of contamination was 2000 m² which includes 1300 m² over six residential blocks and 700 m² of harbour foreshore. The estimated volume of contaminated soil is 1000 m³ with an average depth of 0.5 metres. A plan of the contaminated areas is shown in Fig. 1.

The Radiological Advisory Council, of New South Wales has adopted the recommendation of the U.S. Surgeon General's guidelines for construction of houses over land contaminated with uranium mill tailings⁽⁷⁾. It has recommended removal of contaminated soil.
