SEARCHING FOR A LOST RADIOACTIVE SOURCE IN A MINING-MILLING FACILITY

José Olympio N. M. de Castro, Murillo Senne Jr
Comissão Nacional de Energia Nuclear
Centro de Desenvolvimento da Tecnologia Nuclear
Belo Horizonte - MG, Brazil

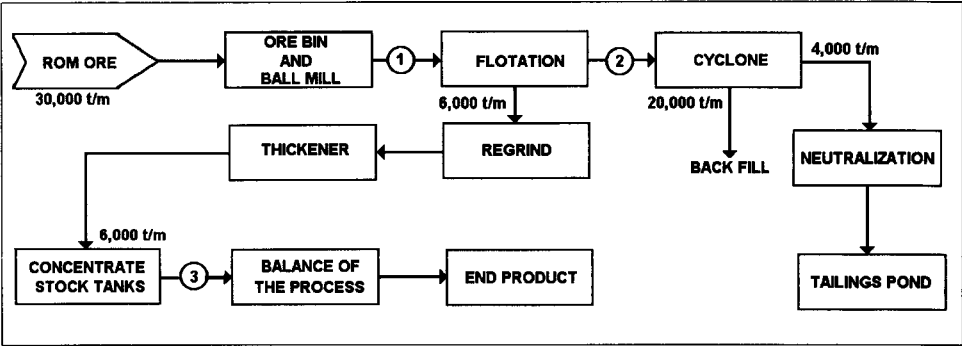
Figure 1 - Process flowsheet

The samples were counted in a HPGE detector, in a low background shielding, for periods of 24 hours each. We found clear peaks of Cs-137 in the samples collected at points 1, 2 and 3 (Figure 1).

The first activity was detected at point 1, on October, 14th, that is, 14 days after the date on which we believed the source was lost. This delay should be attributed to the big ore storage bin that exists between the conveyor-belt and the input to the flotation cell bank. At the same day the activity was detected at the output of the flotation cells (overflow, point 2), which is understandable if we consider the low inventory of material in the flotation cell bank.

On the other hand, it took at least 2 more days for the activity to appear at point 3, the output of the concentrate stock tanks, where it appeared extremely diluted. This time lag and dilution can be easily explained by the volumes of the mill, thickener and concentrate stock tanks.
