Maintenance of the buried neutron irradiator

Grassi E., Villella A., Soppe E., Carelli J.

Nuclear Regulatory Authority, Buenos Aires, Argentina

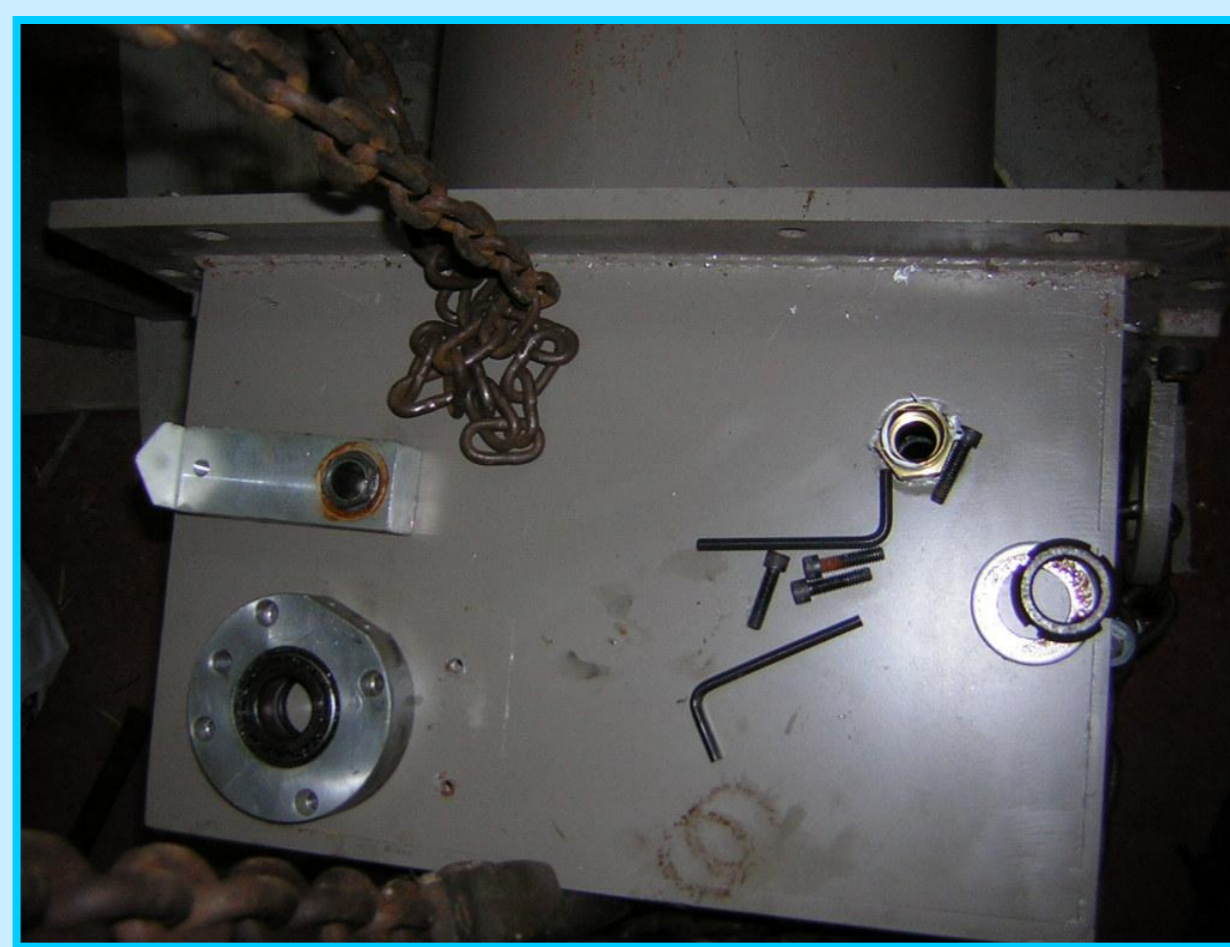
Figure 6. Bearings

Previous attempts had been focused on the air pressure line as well as to the irradiator pipe which had been also purged by air blowing and a treatment to remove the rusty affecting the bearing.

Problems arising from mechanical operation to select sources were solved after replacing the bearing.
