Lessons from Three Major Fires in the UK Non-Nuclear Sector

Gareth Thomas
Health & Safety Executive (HSE)
Government Buildings, Ty Glas, Llanishen, Cardiff, CF14 9ES, UK

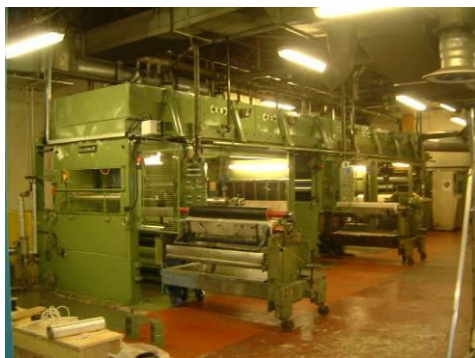
Figure 1: Polyester coating machine

Three ^{210}Po anti-static devices (total activity 5.55GBq) were fitted to a polyester coating machine which, together with the coating machine, were damaged beyond repair. The Company's Radiation Protection Adviser identified significant contamination at various locations inside the plant and protection measures were immediately put in place. There was no evidence of contamination spreading outside the building.

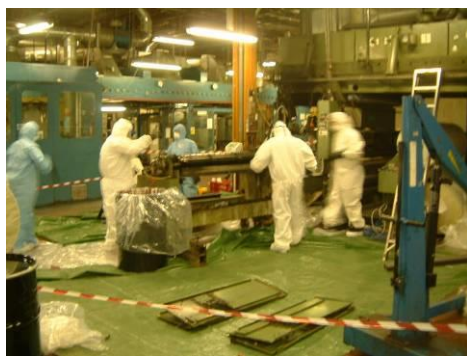
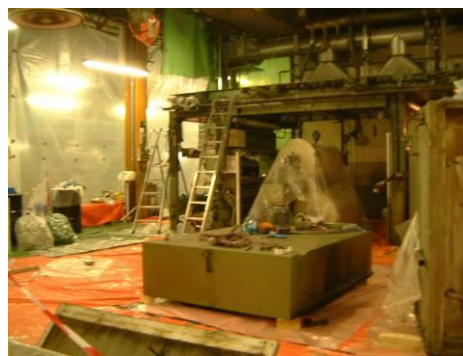
Figures 3 and 4: Decontamination of industrial plant

A specialist decontamination contractor was employed and it took up to 20 days, involving dismantling an exhaust ventilation system and decontaminating large sections of plant and the building itself, to complete the work. A large quantity of alpha contaminated waste was produced and sent for disposal.

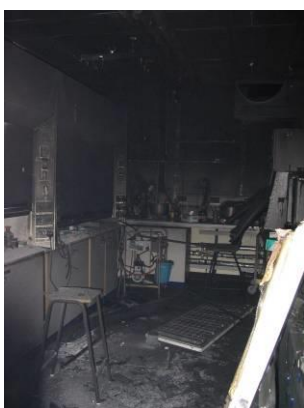
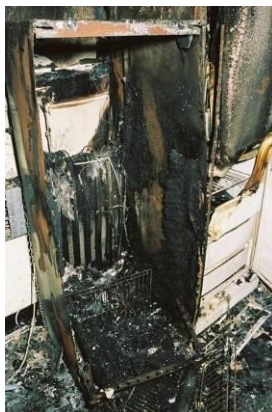
Figure 6: Radiochemistry lab Figure 7: Refrigerator Figure 8: Fire service personnel arriving

The fire originated within a refrigerator containing quantities of both ^3H and ^{14}C in a variety of different solvents located in the radiochemistry laboratory. Upon ignition of an explosive atmosphere, the refrigerator door was blown across the laboratory, the fridge was destroyed, the adjacent freezer was destroyed, and flames engulfed the entire room, melting the plastic extract duct work and spalling the wall plaster. The sole occupant of the room at the time happened to be near the door and immediately left without injury. The building was evacuated and the fire was quickly contained and extinguished by the local fire brigade. However, smoke from the fire spread to many parts of the building, possibly back flowing through the air distribution system that was shut down when the fire started. It rapidly became apparent that both ^3H and ^{14}C had migrated throughout the facility inclusive of the office space and laboratories.

On the day of the fire the refrigerator held 740 GBq ^3H and 3.7 GBq ^{14}C . The radiochemical laboratory also contained 30 TBq on a tritium manifold which was fortunately not fire damaged due to its location at the opposite end of the laboratory to the ignition source.

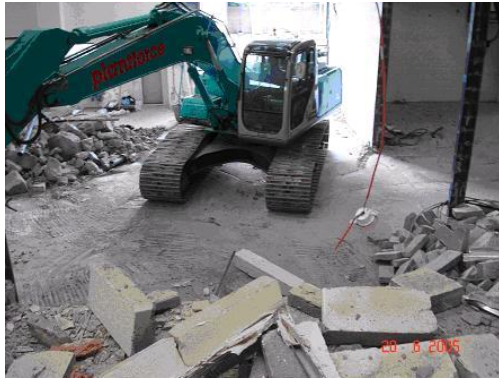
Figure 9: Remediation of building

As a result it became necessary to undertake major remediation works at the site. It was initially hoped that major parts of the building fabric could be retained for reuse. However the extent that ^3H had penetrated the concrete construction materials was not anticipated and this led to the complete removal of the building. The decontamination/decommissioning operation took 16 months to complete. The early

part of the work consisted of characterisation processes together with the design, procurement and installation of the decommissioning ventilation system. The work resulted in the complete removal of the building contents followed by demolition of the structure down to the base slab. The major radiological work was completed by a team of 6 - 8 personnel from NSG Environmental Ltd greatly and a radiochemist from the client.

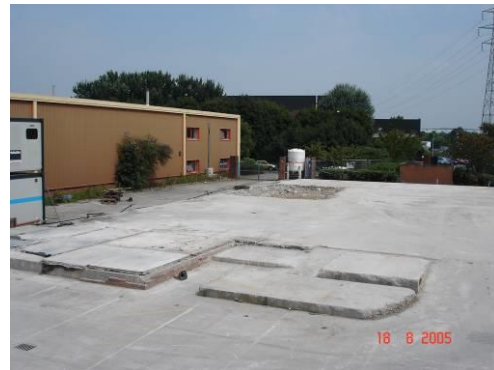
Figure 10: Base slab of building post remediation

Despite the large amounts of activity involved, the total dose accrued by workers in the remediation process was only approximately 1.7 mSv. Risk assessment demonstrates that the residual activity, below statutory control concentrations, remaining in the slab will result in negligible risks to future construction workers and occupiers of the site. Additionally it is anticipated that these residual activity concentrations will rapidly drop with time as the tritium disperses into the wider environment and as a result of radioactive decay.

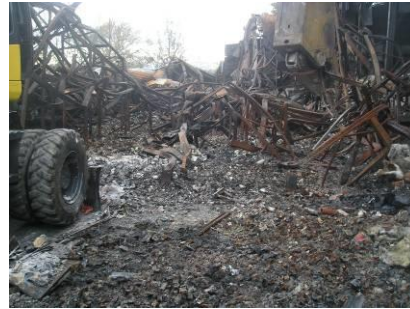
Figure 12: Remains of warehouse and contents

The fire destroyed the building and contents and, due to the temperatures of the fire, significant levels of contamination were present and specialist radiation contractors were required to clean up. The insurers initially estimated the costs to be around £2.5M. The cause of the fire was deemed to be combination of a design flaw and inadequate maintenance leading to a leak of high pressure hydraulic fluid over an electrical ignition source within the forklift truck.

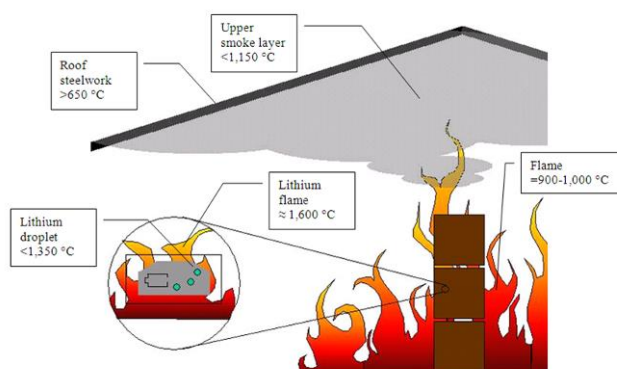
Figure 13: Schematic of fire temperatures

The employer estimated that approximately 500,000 lithium-iron 9V batteries had been present in the building and information was that these ignited at 170°C and burned at around 600°C. Many of these had exploded and been flung up to 50m from the building. This raised the issue of potential chemical contamination and also localised temperature peaks immediately adjacent to the Am-241 foils within each ICSD. The fire service estimated the fire to be between 600° and 900°C and unlikely to exceed 1200°C.

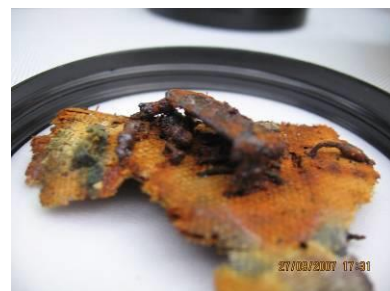
Figure 14: Remains of ICSD ²⁴¹Am foil

Retrieved ^{241}Am foil fragments were coated with extraneous material, possibly ferrous oxide and this made estimation of their activity by monitoring extremely difficult and inaccurate. However, it was estimated that in excess of 96% of the ^{241}Am activity remained attached to the source backing plates. From a health physics perspective this project was problematic as the gamma emissions from the sources were easily masked and there was therefore a considerable amount of loose radioactive contamination below limits of detection for conventional health physics instruments. In order to gain a high degree of confidence a layered monitoring strategy was adopted.

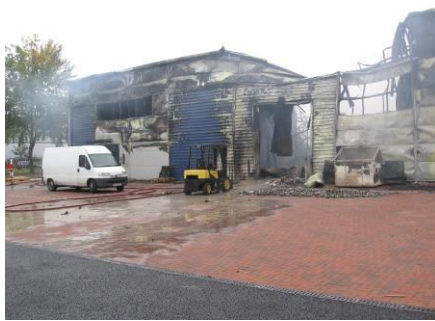
Figure 15: Warehouse after fire extinguished

Plans for removal of the building and its contents had to account for the additional safety hazards of the steel building and shelving framework that had collapsed or been significantly distorted in the heat of the fire and were hanging dangerously in some places. This prevented all contractors entering the building on foot.

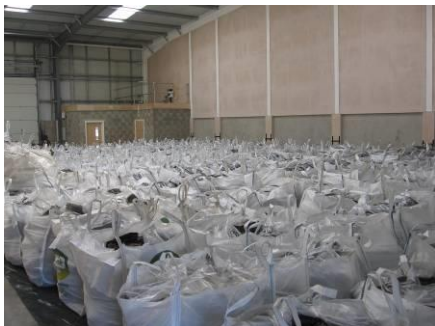
Figure 17: Packaged waste for disposal

Waste was segregated in a vacant neighbouring warehouse that had not been damaged by the fire. It was placed into half-height ISO containers in a manner that minimised the potential for airborne contamination. In total twenty six containers were sealed, monitored and dispatched as LLW at a rate of two to three containers per week.
