Sizewell B and Refuelling Outage

Presenting Author:
Lorna Proctor
Nuvia Limited, Health Physics
lorna.proctor@nuvia.co.uk

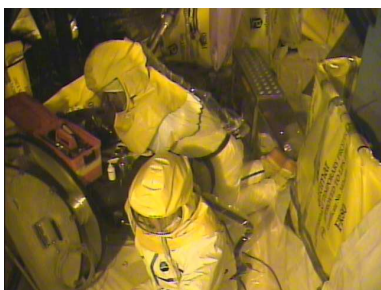
Figure 4 - SG primary side platform work area

Prior to breaking into the primary side of a Steam Generator, the maintenance platform is prepared with a series of removable layers of plastic sheeting to aid with decontamination during, and on completion of the maintenance activities and help prevent a spread of contamination. The team receive mock-up training and pre-job ALARP briefs. Blankets of lead shielding are also used to shield the work area from high dose rate pipework running around the platform.

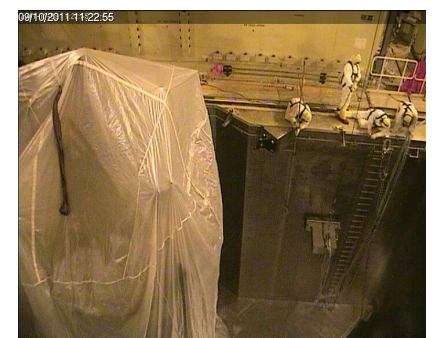
Figure 7 - Upper Cavity Decontamination using RM1 Wall Cleaner suspended from the Polar Crane

After the mid-loop activities and fuel shuffle, the core is reloaded and the RPVH replaced. The HP and decontamination team carry out a thorough decontamination of the refuelling cavity using remote and manual techniques. Figure 7 shows the upper cavity during decontamination with a protective cover over the RPVH:

- Decontamination of the upper and lower cavity as well as the fuel upender pit usually takes around 20 hours.
- Methodology is important to prevent cross contamination.
- A temporary barrier is used at the top of the lower cavity ladder to ensure the upper cavity remains relatively clean (generally <250 cps by large area smear).
- The cavity walls are cleaned using a special wall cleaner (RM1) attached to the reactor building polar crane to ~100 cps.
