Lessons from Three Major Fires in the UK Non-Nuclear Sector

Gareth Thomas
Health & Safety Executive (HSE)
Government Buildings, Ty Glas, Llanishen, Cardiff, CF14 9ES, UK

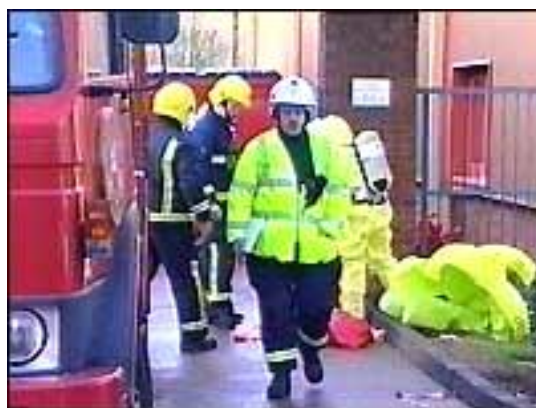
Figure 6: Radiochemistry lab Figure 7: Refrigerator Figure 8: Fire service personnel arriving

The fire originated within a refrigerator containing quantities of both ^3H and ^{14}C in a variety of different solvents located in the radiochemistry laboratory. Upon ignition of an explosive atmosphere, the refrigerator door was blown across the laboratory, the fridge was destroyed, the adjacent freezer was destroyed, and flames engulfed the entire room, melting the plastic extract duct work and spalling the wall plaster. The sole occupant of the room at the time happened to be near the door and immediately left without injury. The building was evacuated and the fire was quickly contained and extinguished by the local fire brigade. However, smoke from the fire spread to many parts of the building, possibly back flowing through the air distribution system that was shut down when the fire started. It rapidly became apparent that both ^3H and ^{14}C had migrated throughout the facility inclusive of the office space and laboratories.

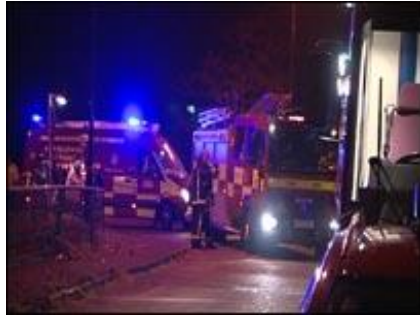
Figure 11: Fire service personnel arriving

The Fire Service let the fire burn throughout the night and under the UK National Arrangements for Incidents involving Radioactivity (NAIR) scheme two health physicists from a nearby nuclear power station attended during the night. The Health Protection Agency Radiation Protection Division also attended. Although the immediate vicinity and roads leading to it were closed until sometime later the following day, since no radioactive materials were detected during air sampling in the plume and sampling on the ground, the decision was taken by the Fire Service not to evacuate any nearby residential areas. Local residents were advised that the smoke may be toxic and therefore to keep windows shut until morning. A junction of the nearby motorway was temporarily closed after smoke drifted across large areas.

offices and deployed an environment management team to monitor the water. No gross contamination was detected. Fortunately there was very little contamination outside the perimeter of the warehouse and no significant radiation doses were received by the public or emergency services. As expected, low radiation dose rates were detected from a fire damaged pile of smoke detector remains located on the forecourt immediately outside the warehouse entrance.

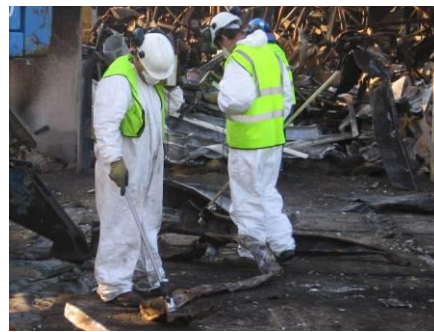
Figure 16: Decontamination personnel

Plans for removal of the building and its contents had to account for the additional safety hazards of the steel building and shelving framework that had collapsed or been significantly distorted in the heat of the fire and were hanging dangerously in some places. This prevented all contractors entering the building on foot.

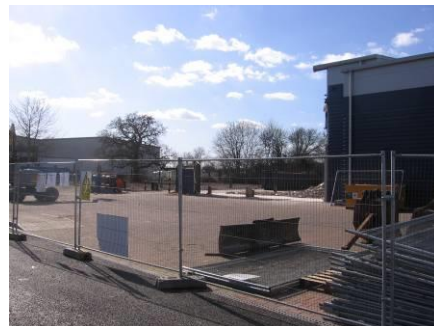
Figure 18: Final site clearance

Eighteen months after the fire the radioactive waste in the warehouse had been removed and packaged, the remains of the building had been demolished, the radioactive and non-radioactive wastes had been cleared from site, and work commenced rebuilding the warehouse. The smoke detector distribution company now operates from a separate location, where an automatic fire sprinkler system is installed.
